Stormwater Committee

Stream Restoration - From City to Pasture to Suburbs
Wednesday, May 12, 2021 - 12:00pm - 1:00pm

Red Clay Creek Restoration at Anson B. Nixon Park

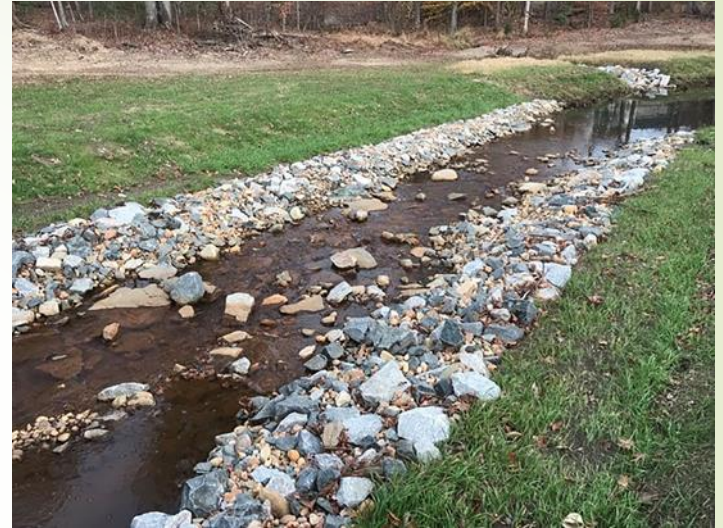
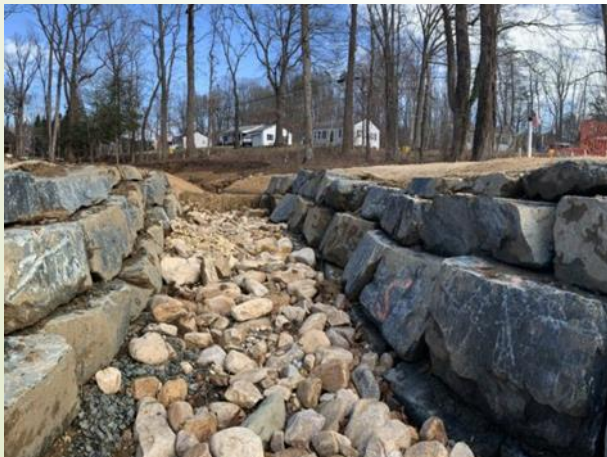
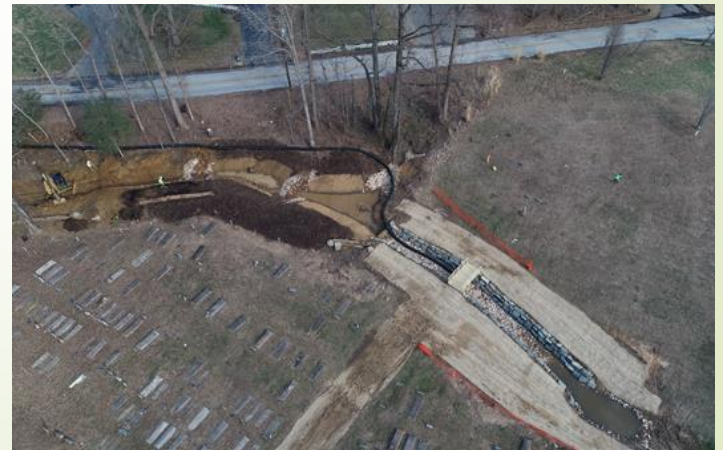
- Rip-Rap channels
- Stream channel straightening
- Heavy armoring of stream banks
- Gabion Baskets

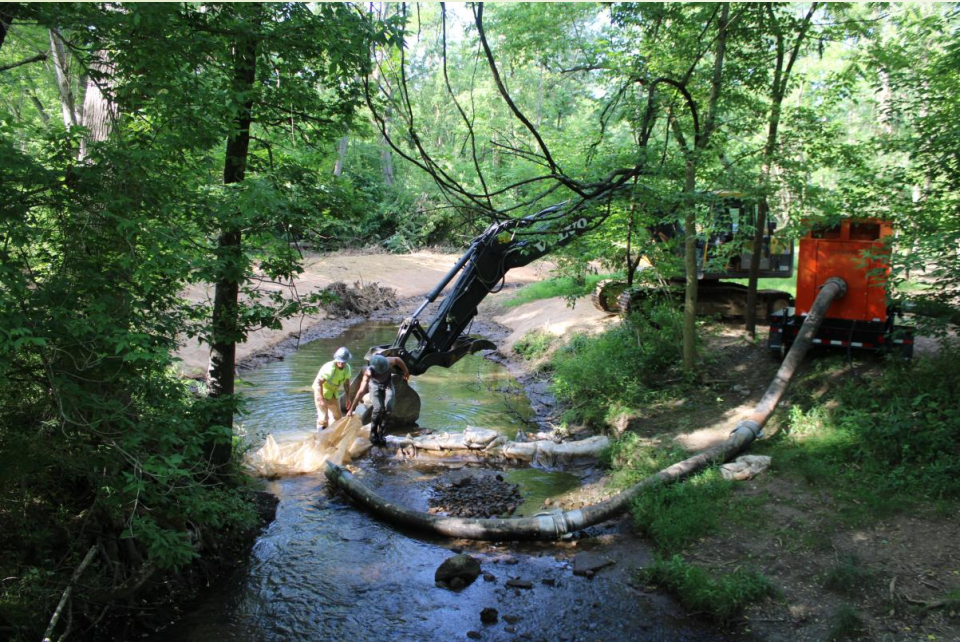
Pumping to work in dry stream

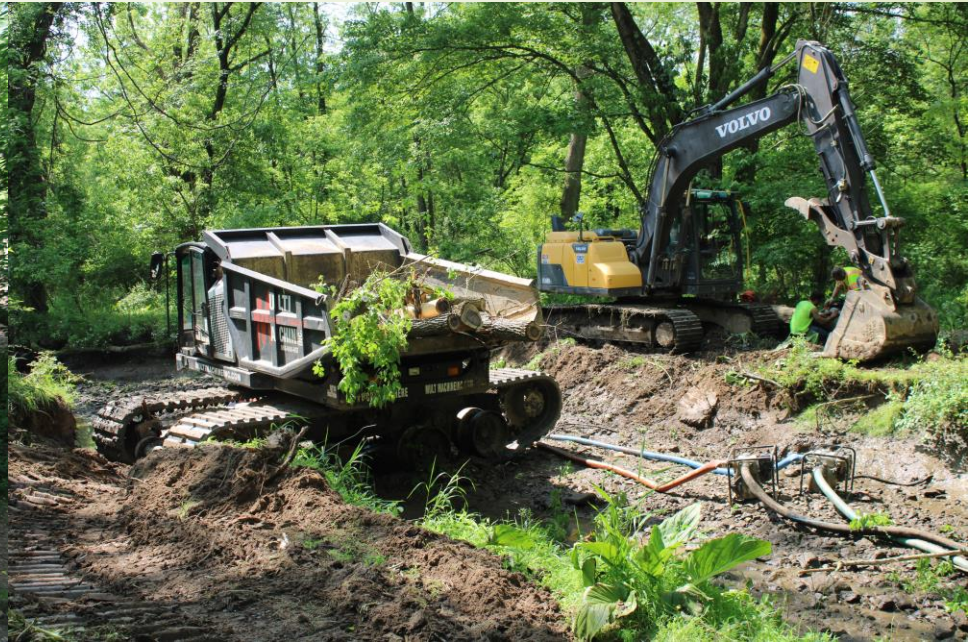
Grading stream banks to 4:1 slope

- Typical practices:
 - Grading stream banks to 4:1 slope
 - Flood plain reconnection
 - In-stream structures, using wood and rock
 - Re-direct flow to center of channel
 - Manage stream bed grade if needed
 - Create pools for habitat
 - Protect eroding banks where there is infrastructure
 - Riparian Buffer enhancement
 - Erosion blanket and native meadow seeding
 - Tree planting buffer 35 ft min.
 - Shrub/live stake planting

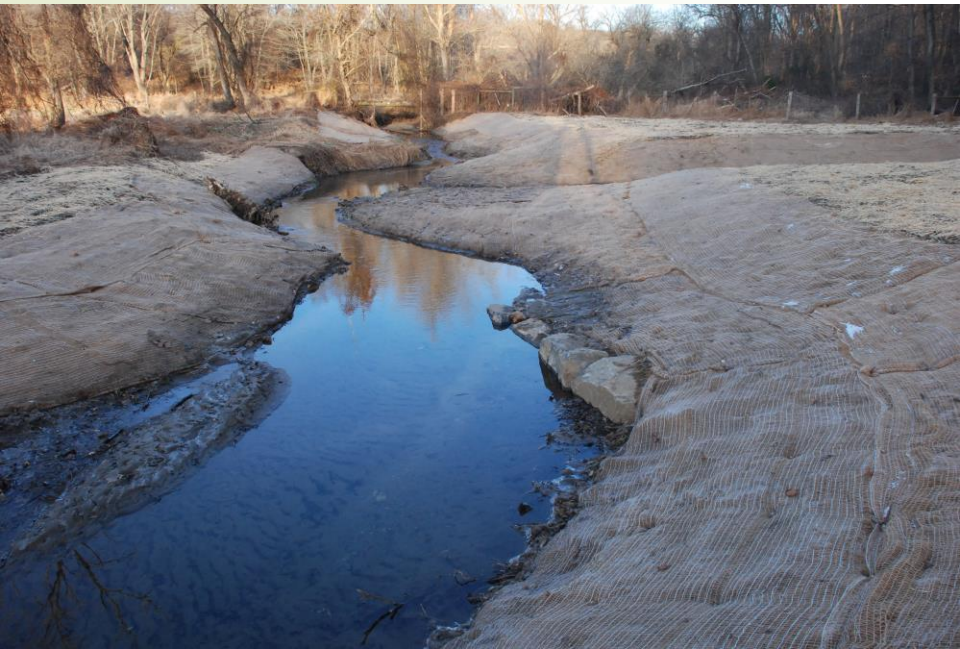
Newly graded banks with erosion blanket

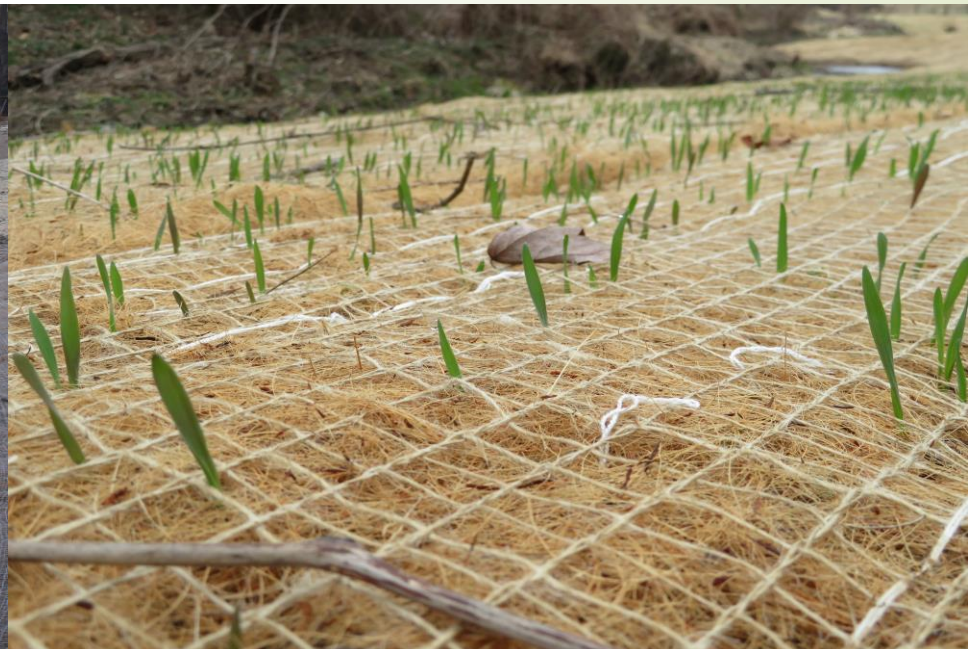
Native grass and wildflower seeding

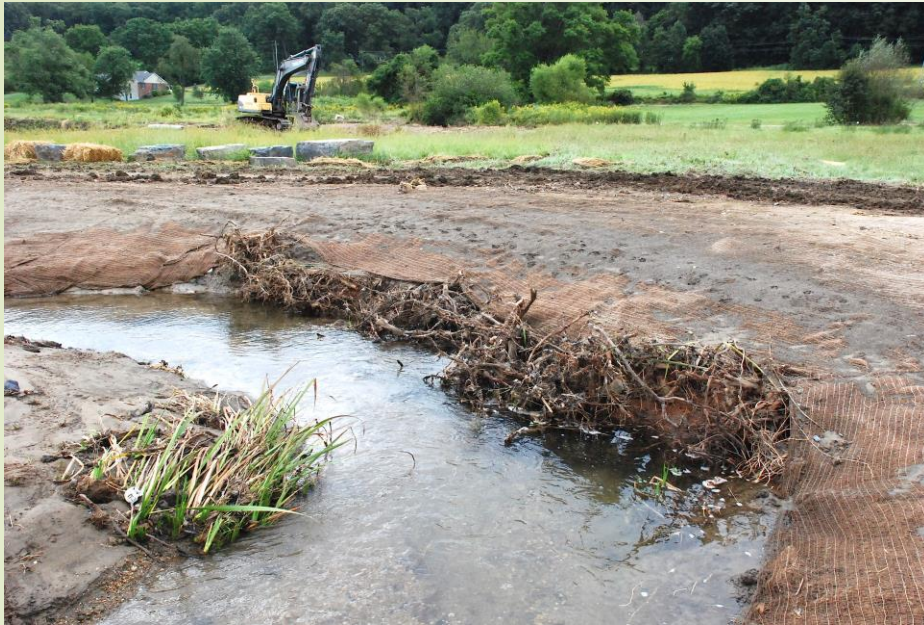
Root Wads used to reduce erosion

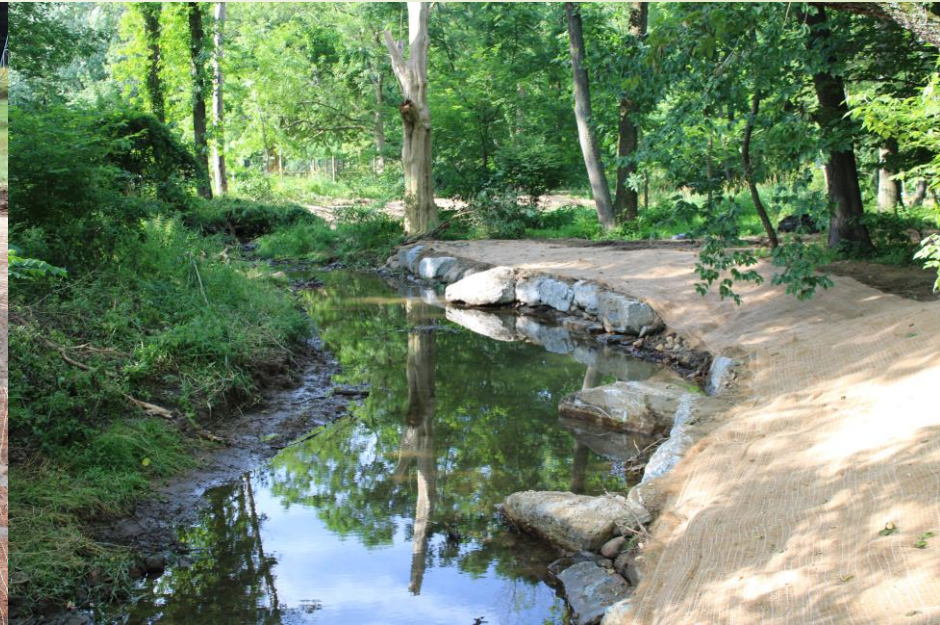
Rock and log vanes

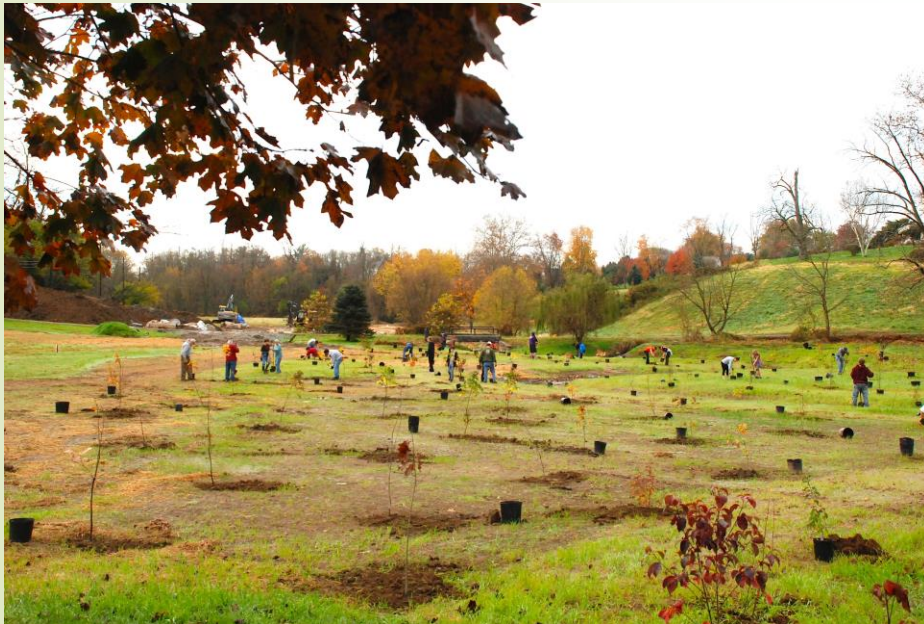
Volunteer buffer tree planting

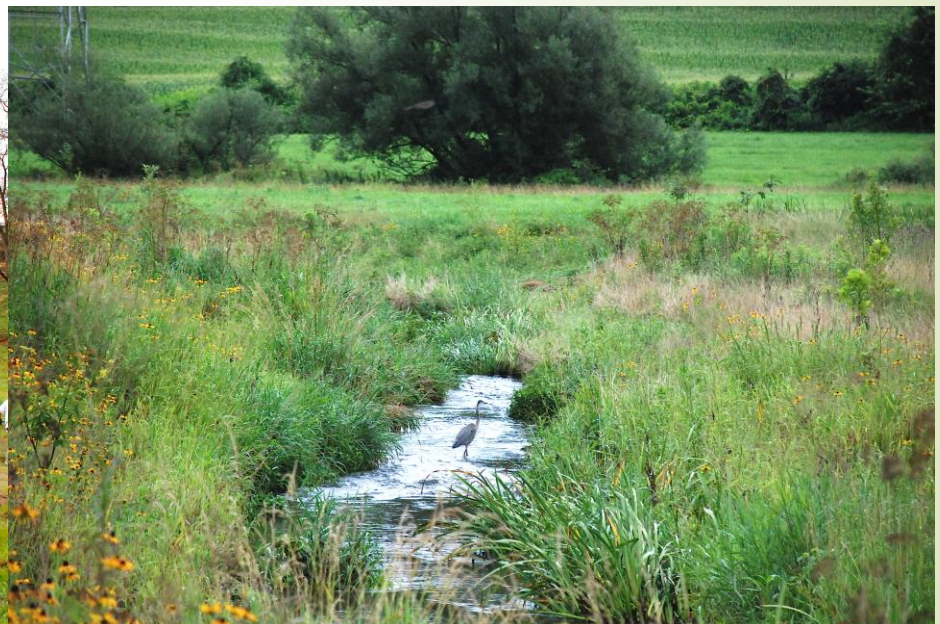
Vegetated stream restoration project

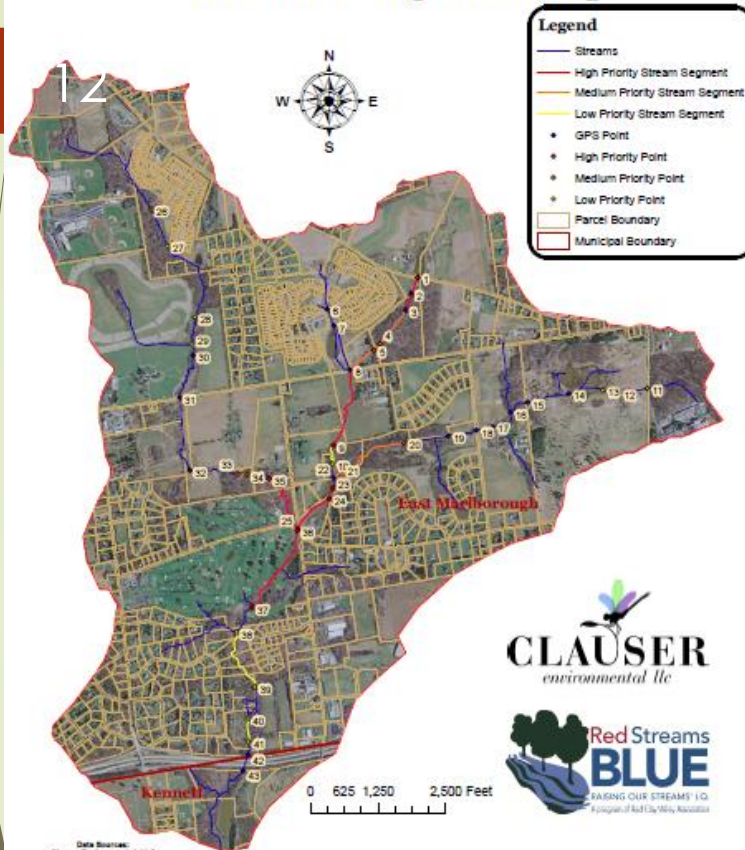
Upper East Branch Red Clay Creek Field Investigation Map

GPS Point Descriptions and Action Items

Point #	Description	Action Item	Key Partners	Red-Blue Priority
1	The mainstem of the Upper East Branch Red Clay Creek begins just upstream of this point at a large on-line dam. Downstream of this point, the streambanks are 3 to 4 feet high and eroded/healed over with meadow and some trees on both sides.	Streambank stabilization, riparian buffer enhancements, tree plantings on west side of stream	Landowner, Tree Vitalize, Conservation District	High Priority
2	Underdrains discharge to this section of stream from the west.	N/A	N/A	N/A
3	There is riparian buffer on both sides of the stream downstream of this point, streambanks are eroded in some areas 3-5 feet high.	N/A	N/A	N/A
4	An unnamed tributary discharges to the stream from the east in this location. The streambanks in the woodlands upstream and downstream of this point are eroded and about 3 to 5 feet high.	Streambank stabilization	Landowner, Conservation District	Medium Priority

5	Upstream of this point, the streambanks are eroded throughout a forested area. Downstream of this point, the riparian zone is mowed to the top of both streambanks to the SR-926 bridge.	Streambank stabilization upstream, riparian buffer enhancement downstream	Landowner, Tree Vitalize	Medium Priority
6	A bridge crosses over a wetland area on an unnamed tributary at this point. There are several stormwater basins that discharge to this area.	N/A	N/A	N/A
7	An abandoned bridge crosses a wetland area on an unnamed tributary at this location.	N/A	N/A	N/A
8	This point is located on the SR-926 bridge. Riparian buffer enhancements are installed upstream of this point on an unnamed tributary that drains to the stream from the north.	N/A	N/A	N/A
9	A horse pasture is located upstream of this point and extends to the SR-926 bridge. The livestock have direct access to the stream.	Streambank fencing, riparian buffer enhancement, stabilized watering areas	Landowner, Conservation District, NRCS	High Priority

10	Upstream of this point, the western streambank is mowed to the top of the bank.	Riparian buffer enhancement	Landowner, TreeVitalize	Low Priority
11	The stream channel in this headwaters section is stable and intermittent. Roadway storm drainage flows through a maintained grass swale. Downstream the channel flows through a naturalized area and is well buffered and stable.	Create a bioretention swale along the roadway	Longwood Gardens	Low Priority
12	A 6 inch iron pipe drains to the stream from the south in this location and was likely a tile drain. This area appears to have been tiled and ditched in the past.	N/A	N/A	N/A
